Presentation

On January 22, 2018 not inspecting every tank came back to bite us.

An operator I, while doing the rounds noticed that the drive chain on grit chamber #1 was missing. The operator notified the Superintendent and the maintenance man. Maintenance and the operator started draining down tank to recover the chain. The crew found the chamber full of grit and specified the need to call in Professional Service help. (See note #1&2.)

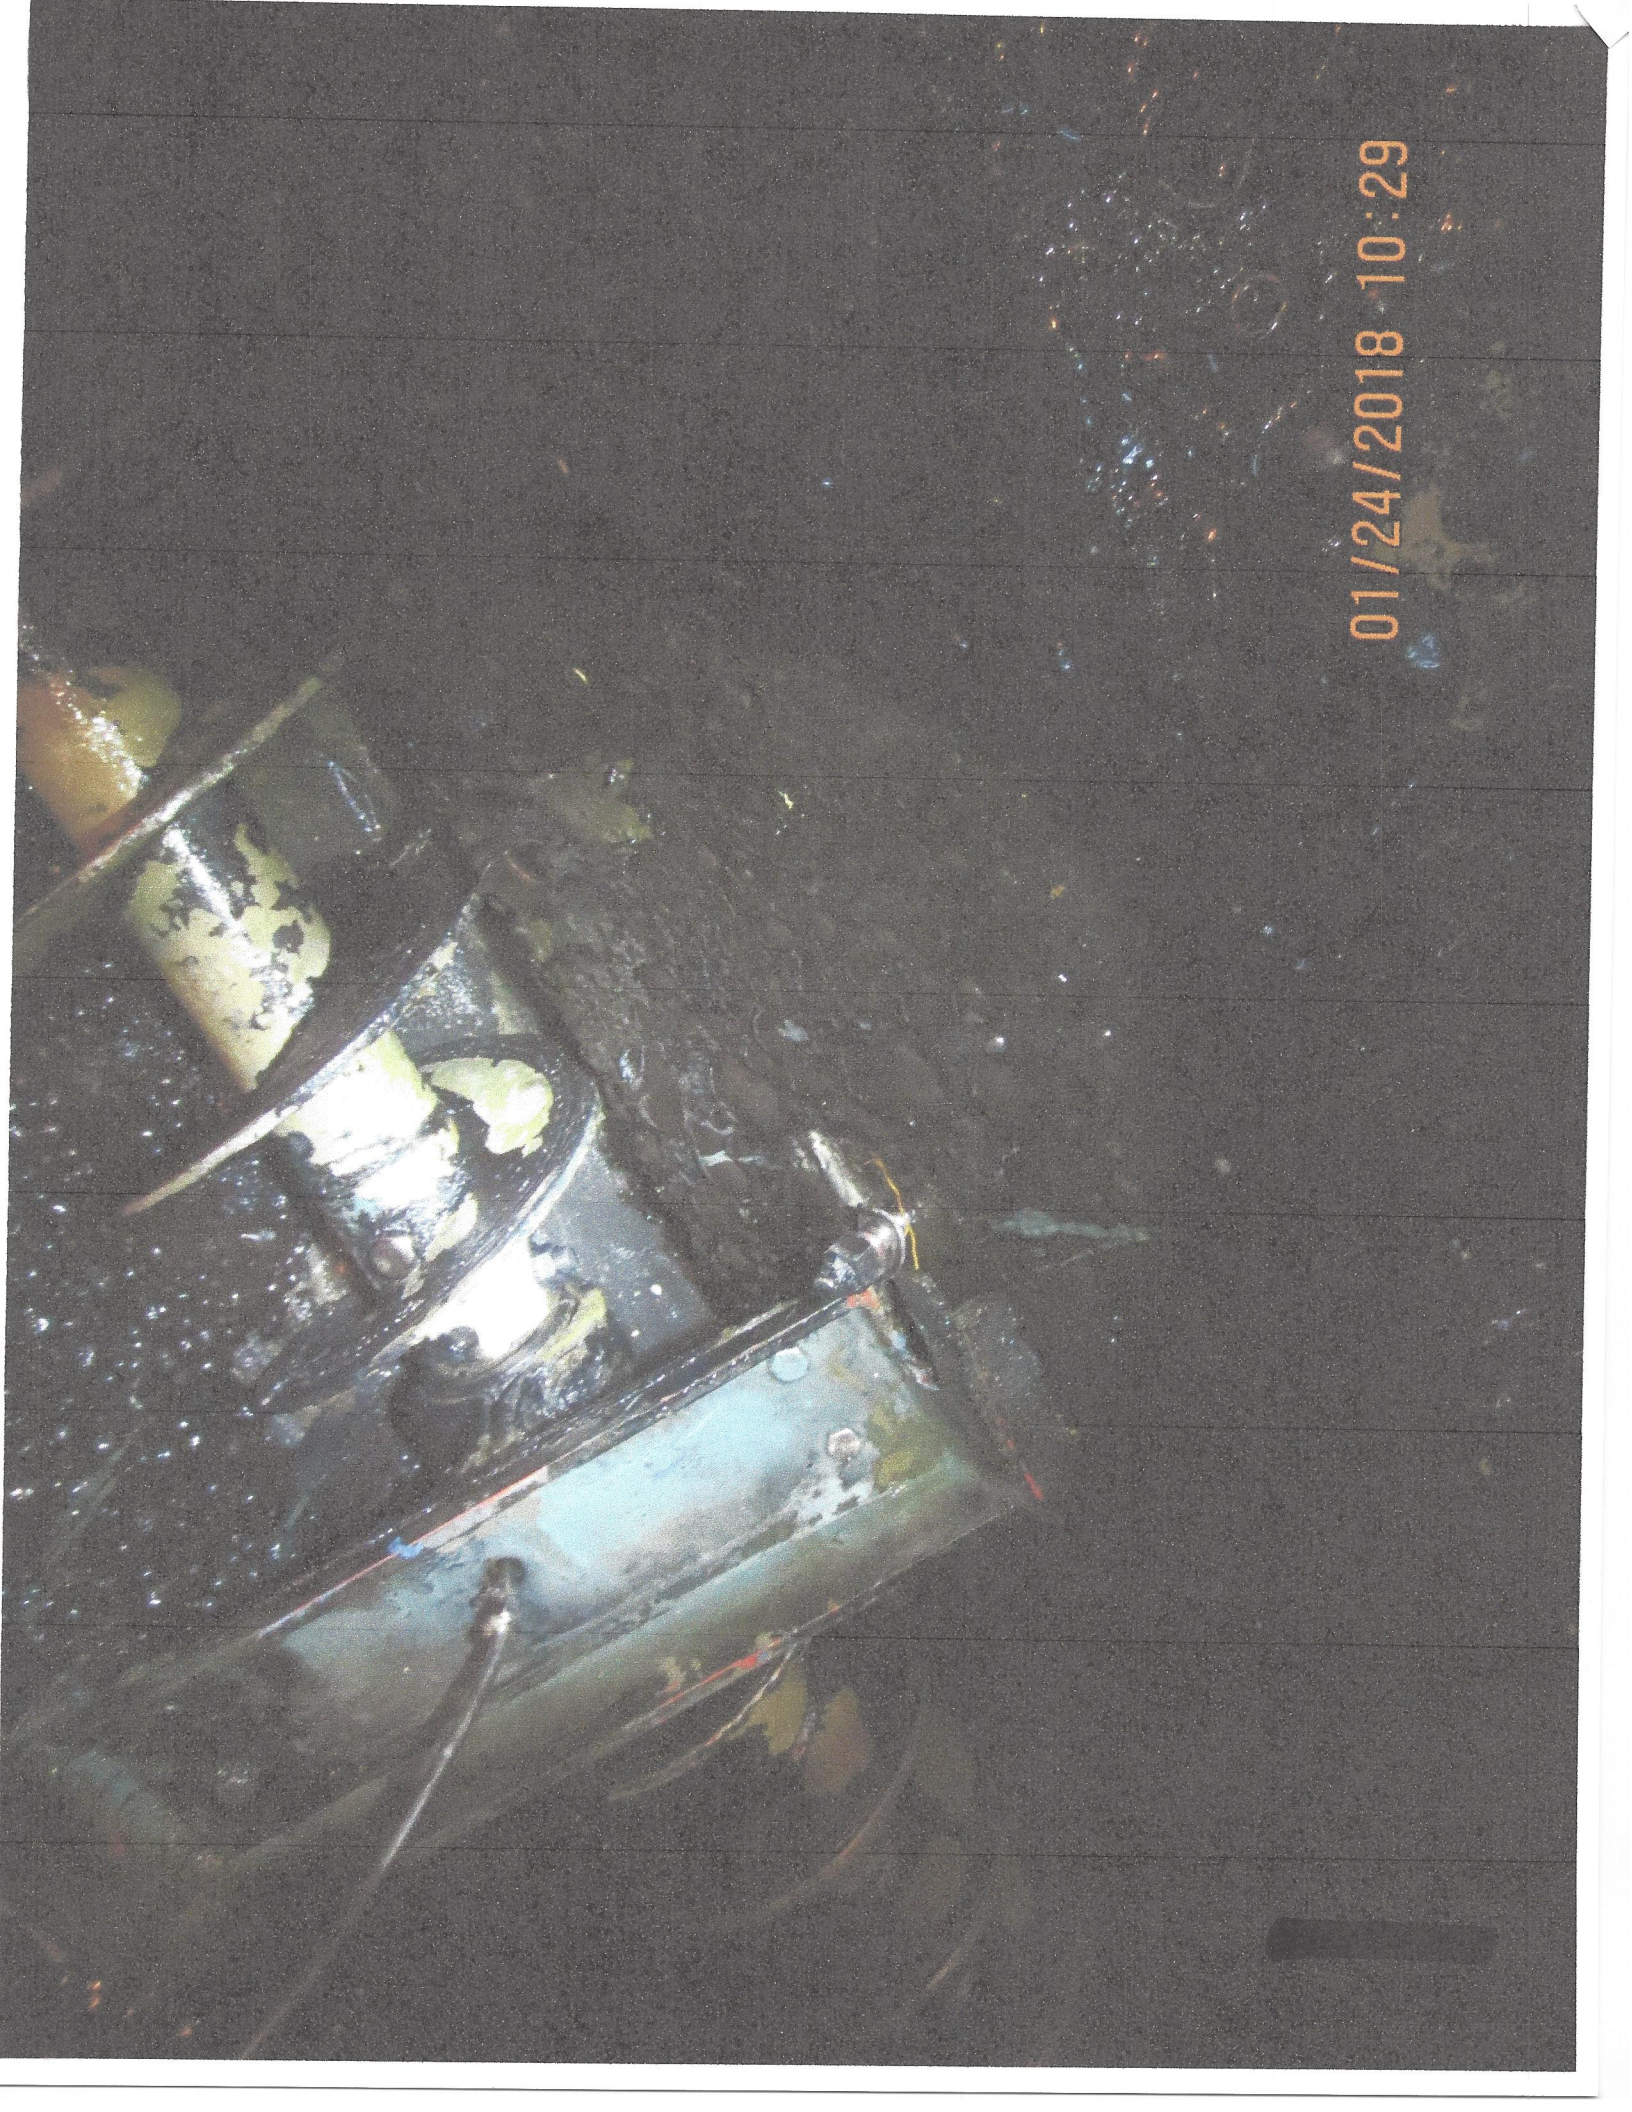
01/24/2018 10:29

January 24, 2018: Paul from Ted Berry arrives with his crew. Vacuumed out grit chamber. (See note #3). We inspected the Mechanism and found a broken wall bearing assembly, Broken Drive bearing assembly, and broken center hanger bearing assembly, broken and bent drive chain, damaged drive sprockets, broken chain lightener and miscellaneous bent and broken bolts. (See pictures 1-3 and note #4) Inspection revealed that a bolt had probably vibrated loose, (picture #4) dropped out of place and jamming the mechanism causing the screw to shatter the wall mounts and brackets. Once the mounts were gone and the screw was free floating. The screw, turning in the grit pulled away from the drive unit snapping the chain and destroying the drive sprockets and chain tensioner.

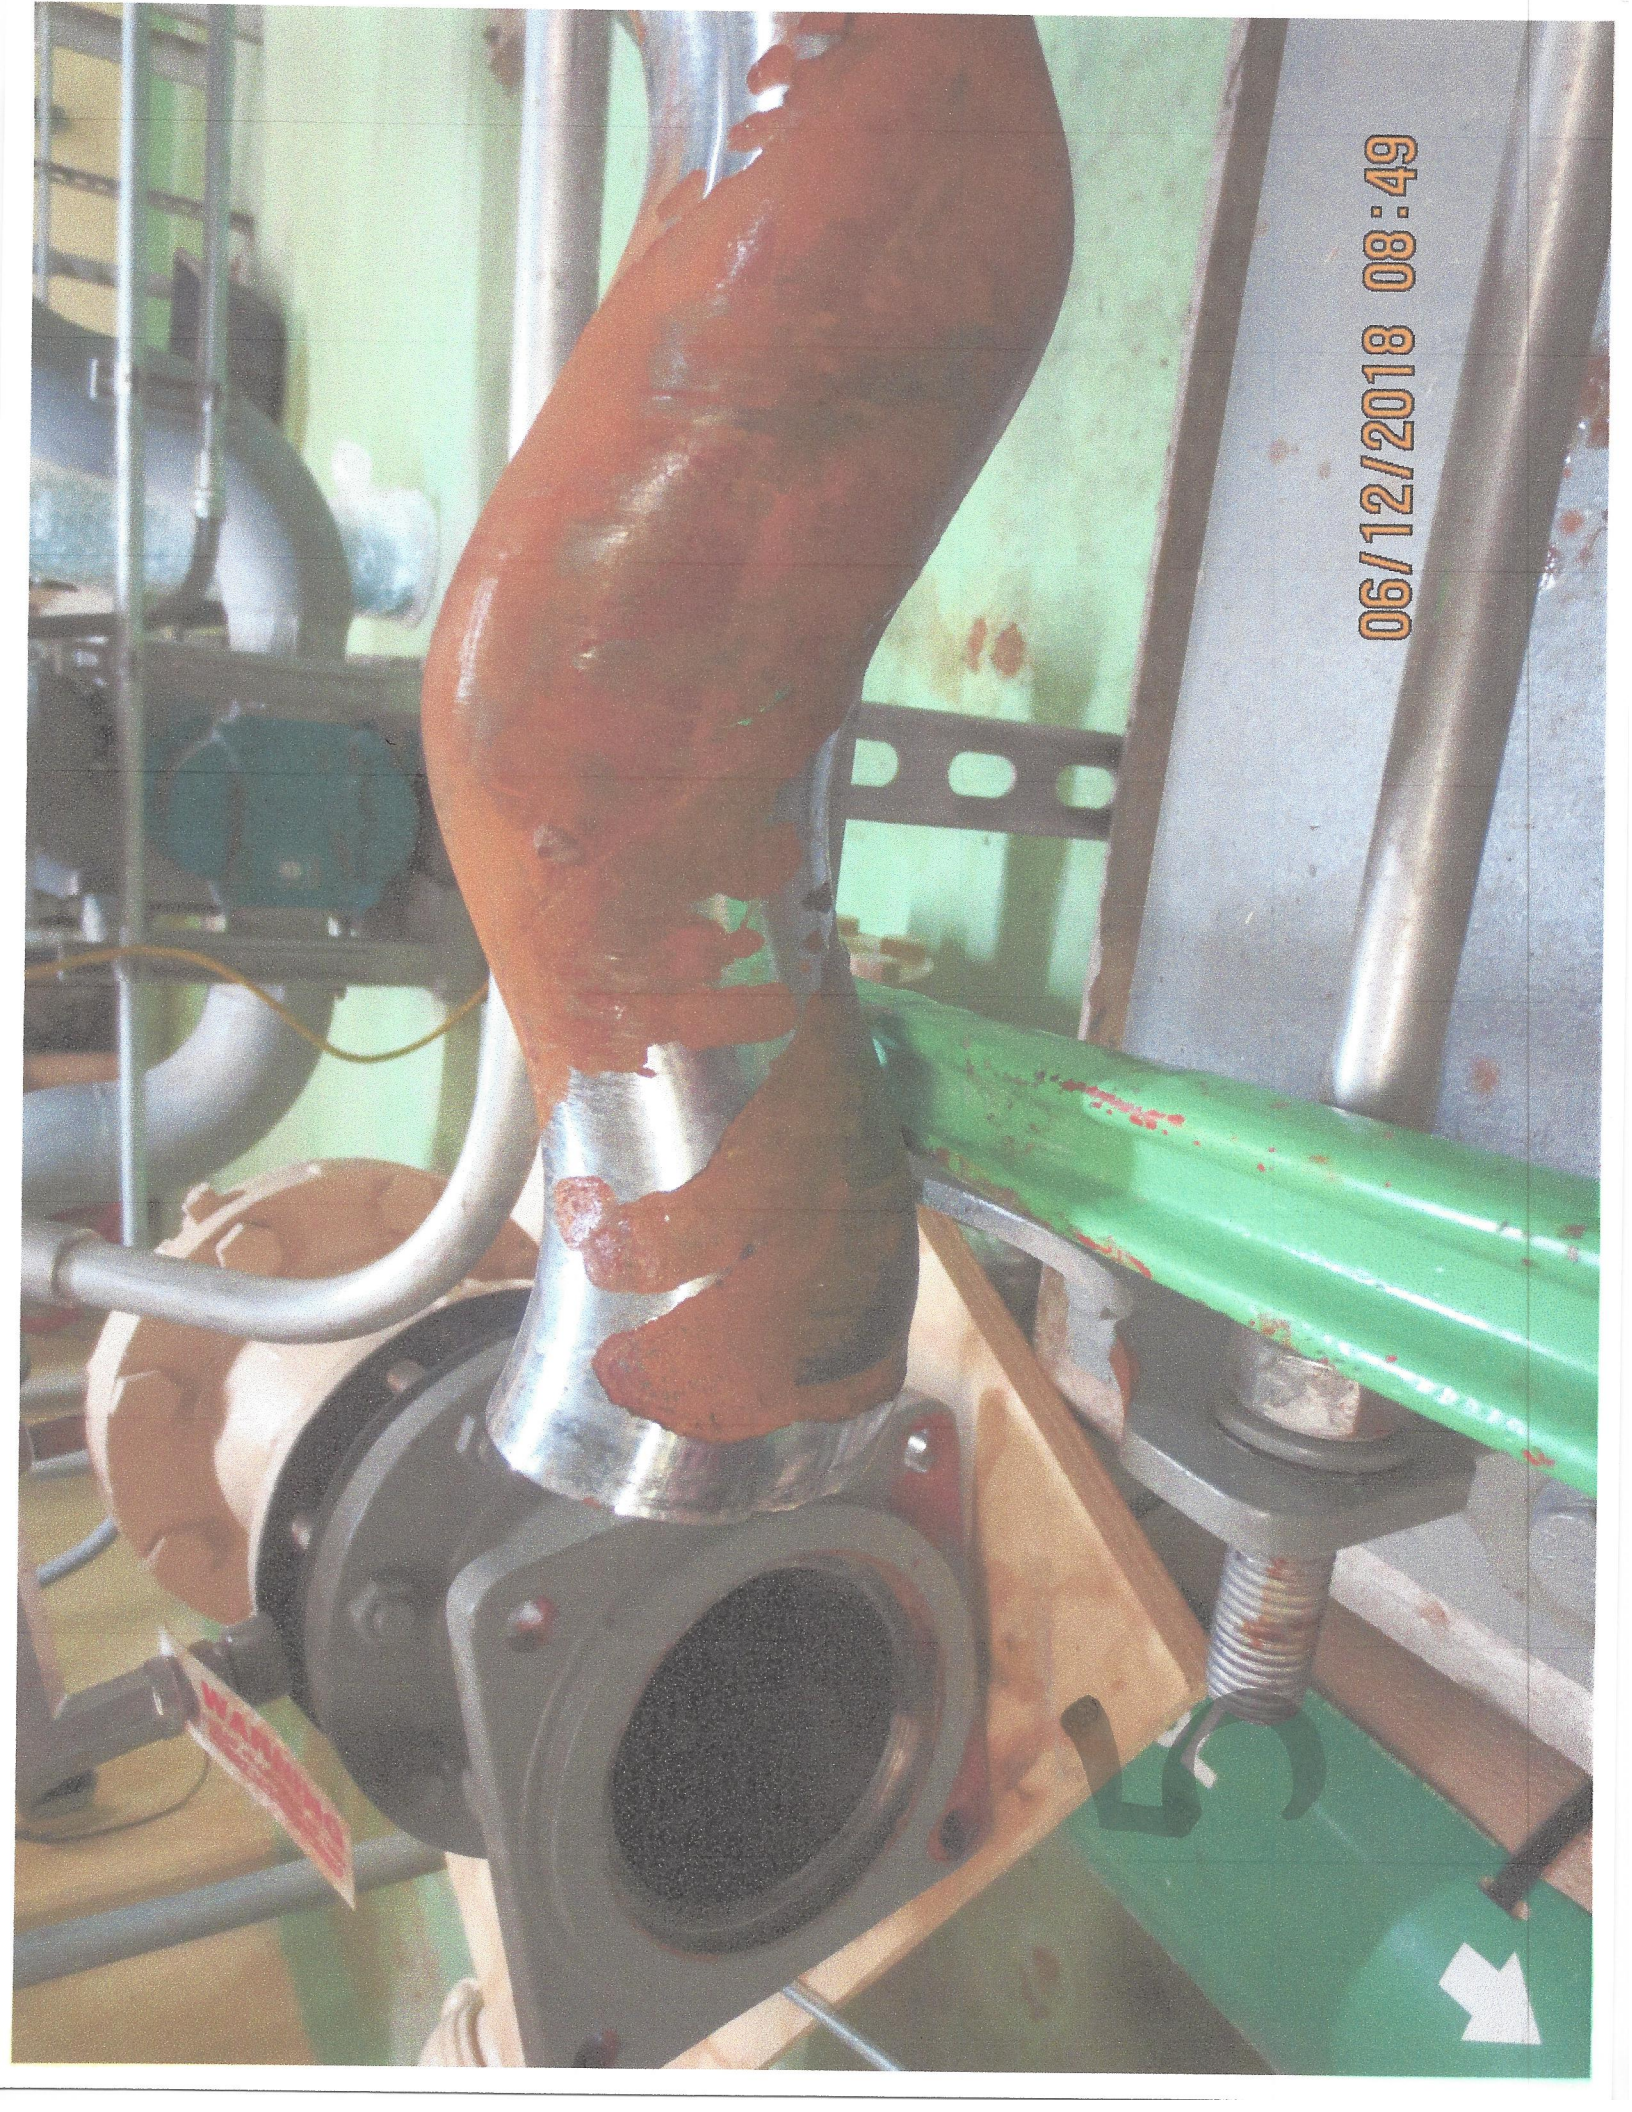
06/12/2018 08:49

I wish I could say that this is the total expense for this break down but the month of April had an average influent daily flow of 3.36 MGD. This type of flow requires 2 grit chambers to remove all of the grit but we only had one. Whatever grit got by our one and only grit chamber on line was caught in the primary clarifier and pumped out by our primary pumps but little wear is expected in these pumps. The diaphragm pumps pump the grit laden sludge to the sludge holding tanks where our Dewatering pumps pump it to the screw press. These dewatering pumps are a progressive cavity pump that doesn't handle grit very well (See Picture #5&6). They are in the process of being rebuilt. To rebuild these pumps we will need to replace the stator at \$1,451.00 each and the rotor at \$3,297.00 each. We have three pumps that are showing the wear. $\$1,451.00 + \$3,297.00 = \$4,748.00$ per pump, X 3 pumps = \$14,244.00 for parts alone (see notes 36&37). It will take two men 8 hours each to disassemble, rebuild, and reinstall each pump for a total of \$1083.84 (see note 38)
