STRUCTURAL ASSESSMENT REPORT

**PRINCESS THEATER
25 GREEN SQUARE
BERLIN, NEW HAMPSHIRE**

Prepared for:
City of Berlin

August 12, 2019

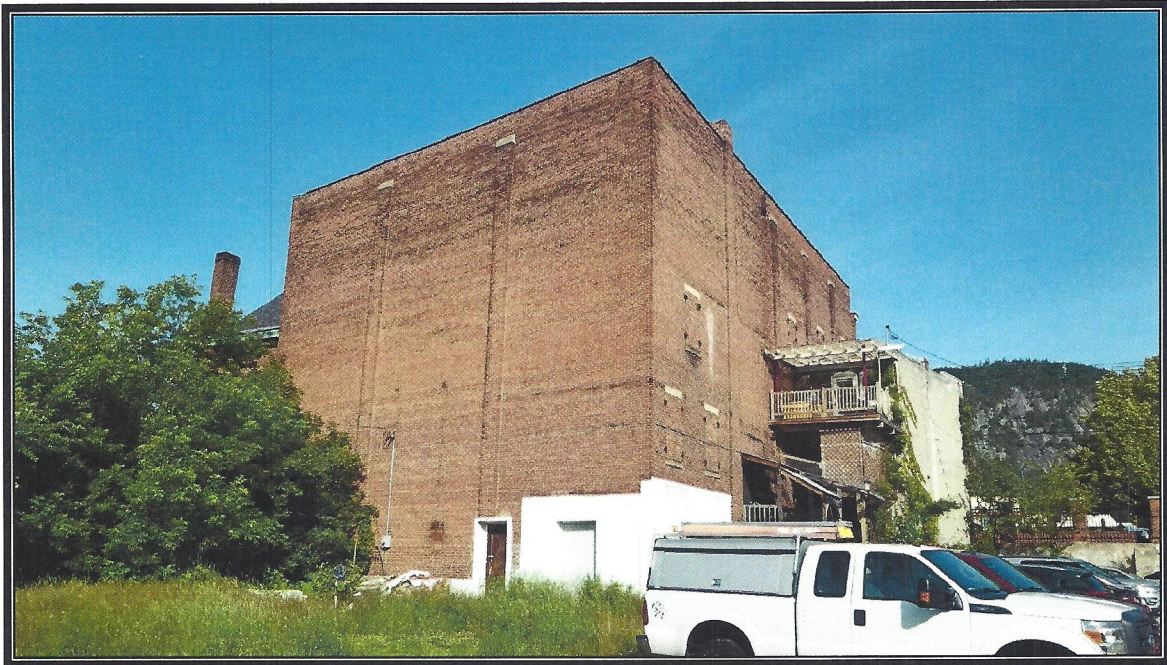
During my site visit, I observed that the brickwork on the sides and back of the building appears to be in fair to good condition (see Photo 1). A portion of the original brick parapet along the front of the building was damaged by the fire and removed by the previous owner. I confirmed that the bricks above the windows in the southwest corner of the building are leaning toward the sidewalk and are in danger of falling (see Photo 2). The remaining bricks in the front of the building appear to be stable. There is a large sign fastened to the bricks on the front of the building (see Photo 3). The connections of this sign to the bricks could not be observed.

Photo 1: Back and north side of the building.

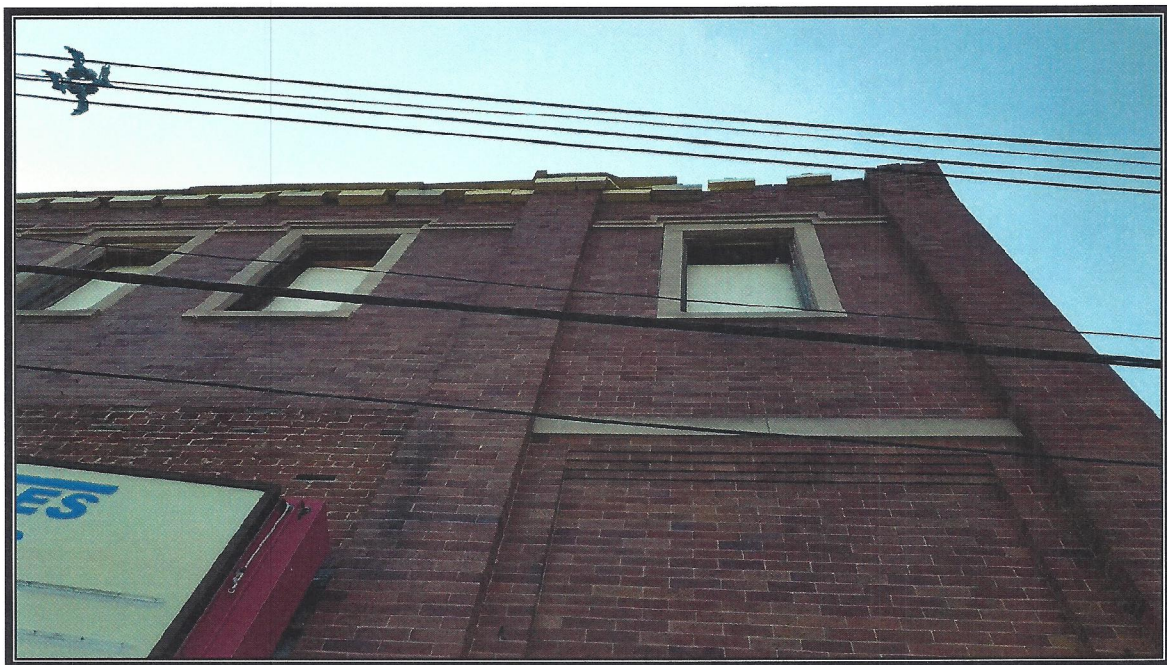
Photo 2: Leaning bricks on top of the front side of the building.

The loose bricks, above the windows and along the front of the building, are in danger of falling onto the sidewalk and I recommend that they should be removed as soon as possible. The connection between the sign and the existing building is questionable and I recommend that the sign should be taken down. Based on the extent of the repairs required to make the building useable and/or safe to occupy, consideration should be given to demolishing the remaining structure.

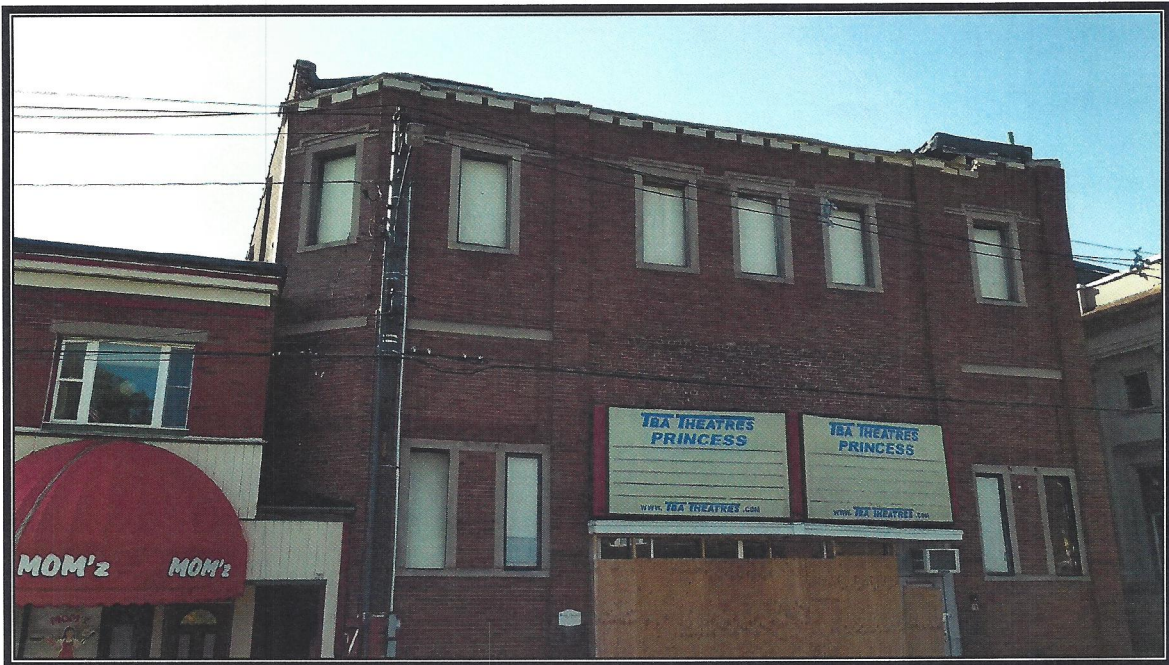
Photo 3: Signs attached to the front of the building.

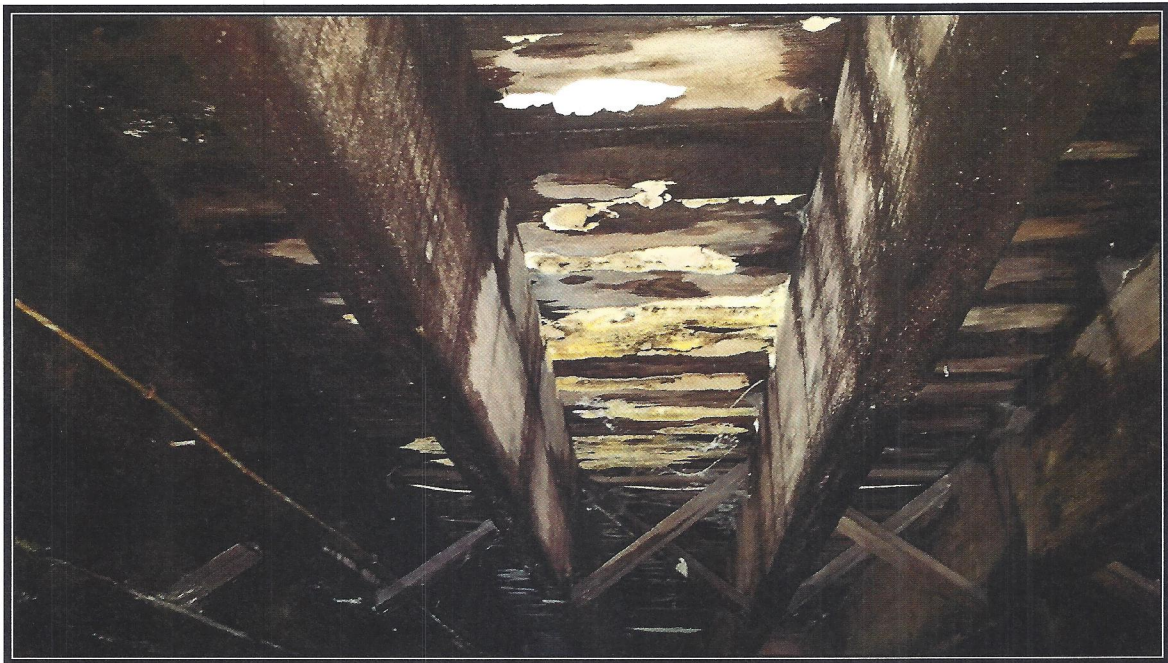
We entered the building through the door at the lower level in the back of the structure. Since there has been a large hole in the roof since winter, water has entered the structure, resulting in several large puddles in the basement. Water was actively dripping through the floor from above, and a significant amount of fungus was growing on the wooden floor framing (see Photo 4). The sloped floor is framed with a series of wooden beams and joists supported by steel columns. One section of the wooden floor framing, near the middle of the northern wall, had partially collapsed (see Photo 5). The wood-framed stairs in the front of the building, from the lower level to the main floor, appeared to still be in good condition.

The original roof structure was severely damaged by the fire in 2013. Repairs to the roof structure were started but never completed. During the winter of 2019, a portion of the damaged roof structure collapsed onto the floor below, taking the suspended ceiling framing with it and damaging the mezzanine framing. The impact of the roof collapse caused a portion of the main level floor framing to partially collapse as well. Fungus has started to grow on the wood framing in the cool wet basement area.

Photo 4: Mold and fungus growing on floor framing.

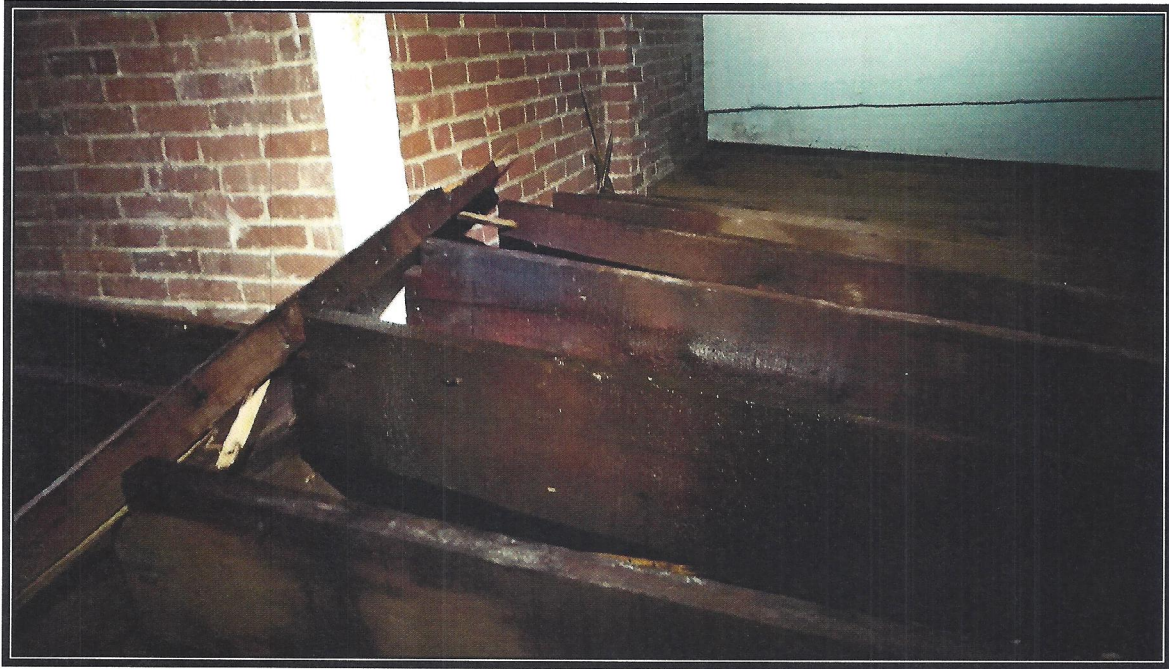
Photo 5: Partially collapsed floor framing.

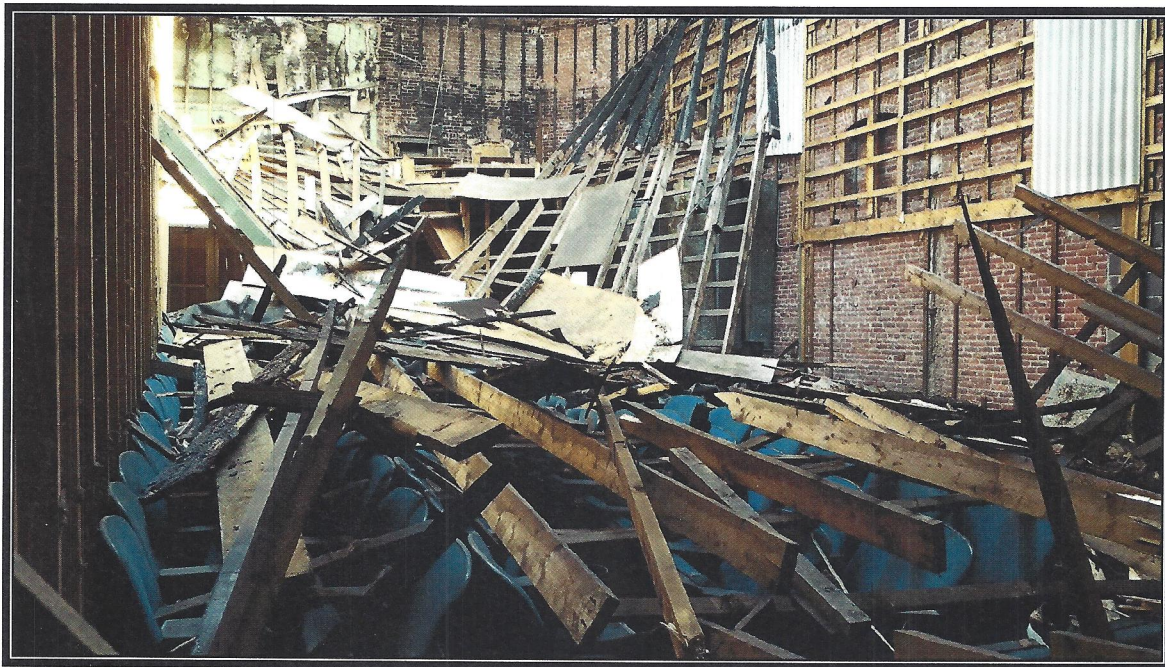
From the main floor level, I observed that the suspended ceiling and approximately 20% of the wood-framed roof structure on the northern half of the building had collapsed onto the floor below (see Photo 6). The areas adjacent to the collapsed roof appear to still be in danger of collapsing (see Photo 7). The portion of the roof along Main Street, that was repaired by the previous owner, is still in place and appears to be stable (see Photo 8).

Photo 6: Ceiling and roof framing on the floor.

Based on my limited observations, I believe that all of the remaining roof and floor framing is in poor condition. If the building were to be restored, we would recommend completely removing the interior framing and reconstructing, using the exterior brick walls and foundation. With the extent of the damage and the amount of work required to bring the structure up to current building code requirements, it would likely cost more to repair the structure than it would cost to construct a new building with the same dimensions.

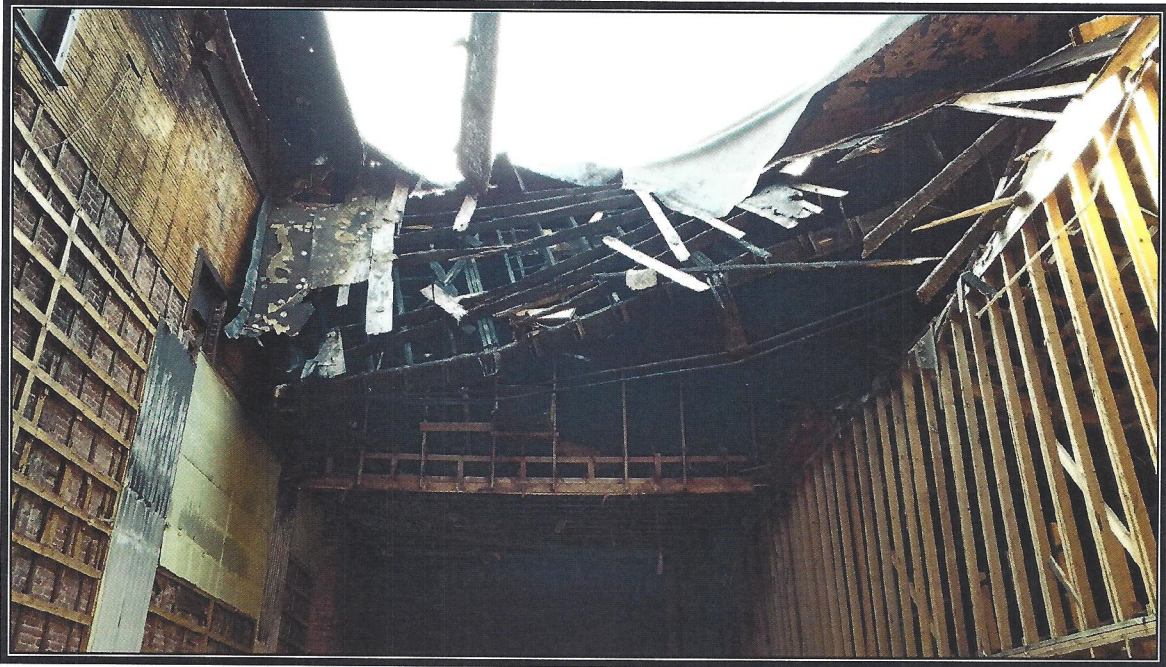
Photo 7: Section of roof framing in danger of collapse.

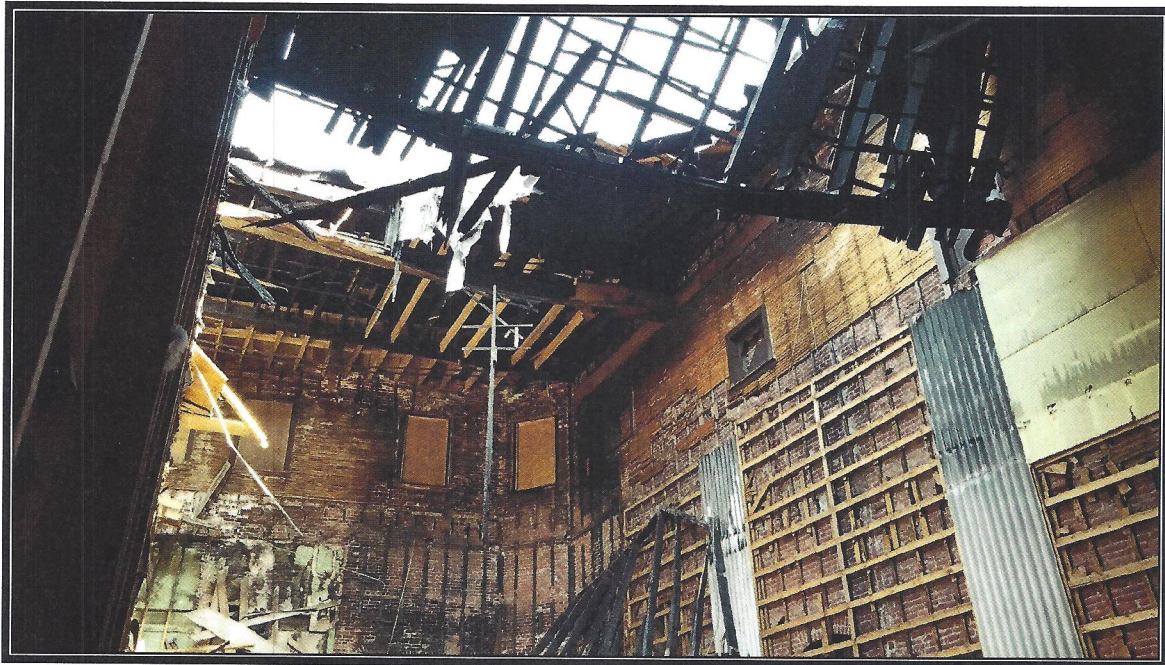
Photo 8: Area of roof framing repaired by previous owners.

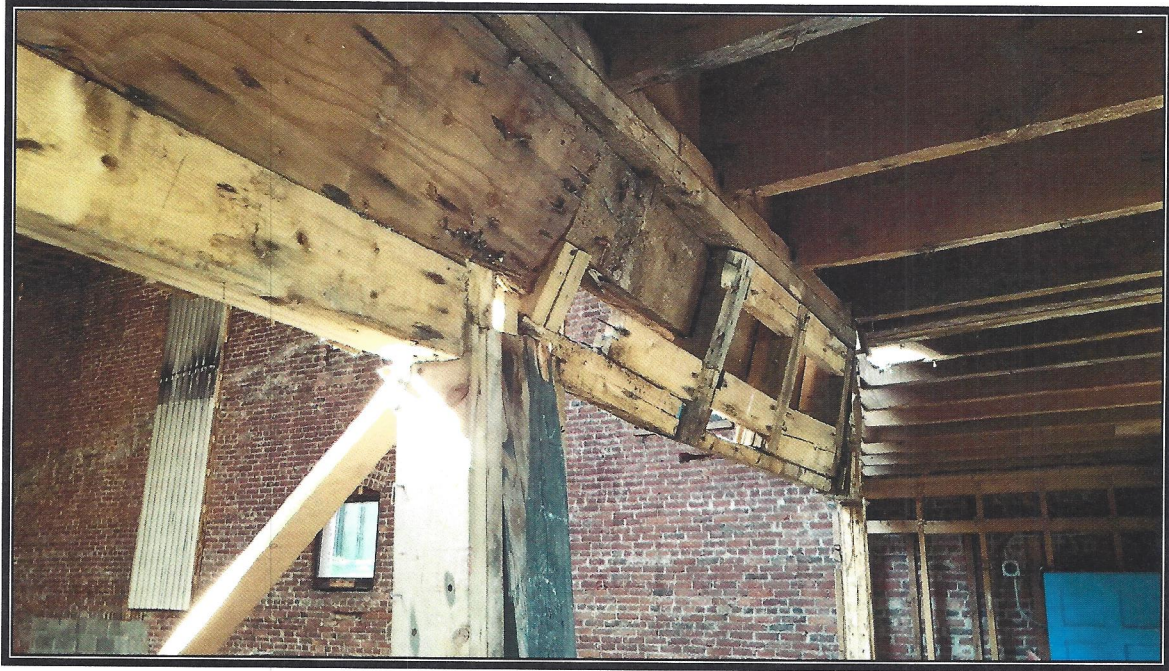
The wooden floor-beam along the inside of the mezzanine floor is leaning and is in danger of collapse. A temporary brace has been installed to help support the framing in this area, but it does not appear to be sufficient (see Photo 9).

Photo 9: Leaning beam supporting mezzanine framing.
