Pre-Demolition NESHAP Building Inspection

Site:
422 Champlain Street
Berlin, NH

Inspection Date: May 16, 2023
Report Date: June 22, 2023
Calex Project: BER-22-001A/B

**Re: Pre-Demolition Building Inspection
Residential Multi-Family Building and Attached Multi-Bay Shed/Garage
422 Champlain Street, Berlin, NH (the Site)**

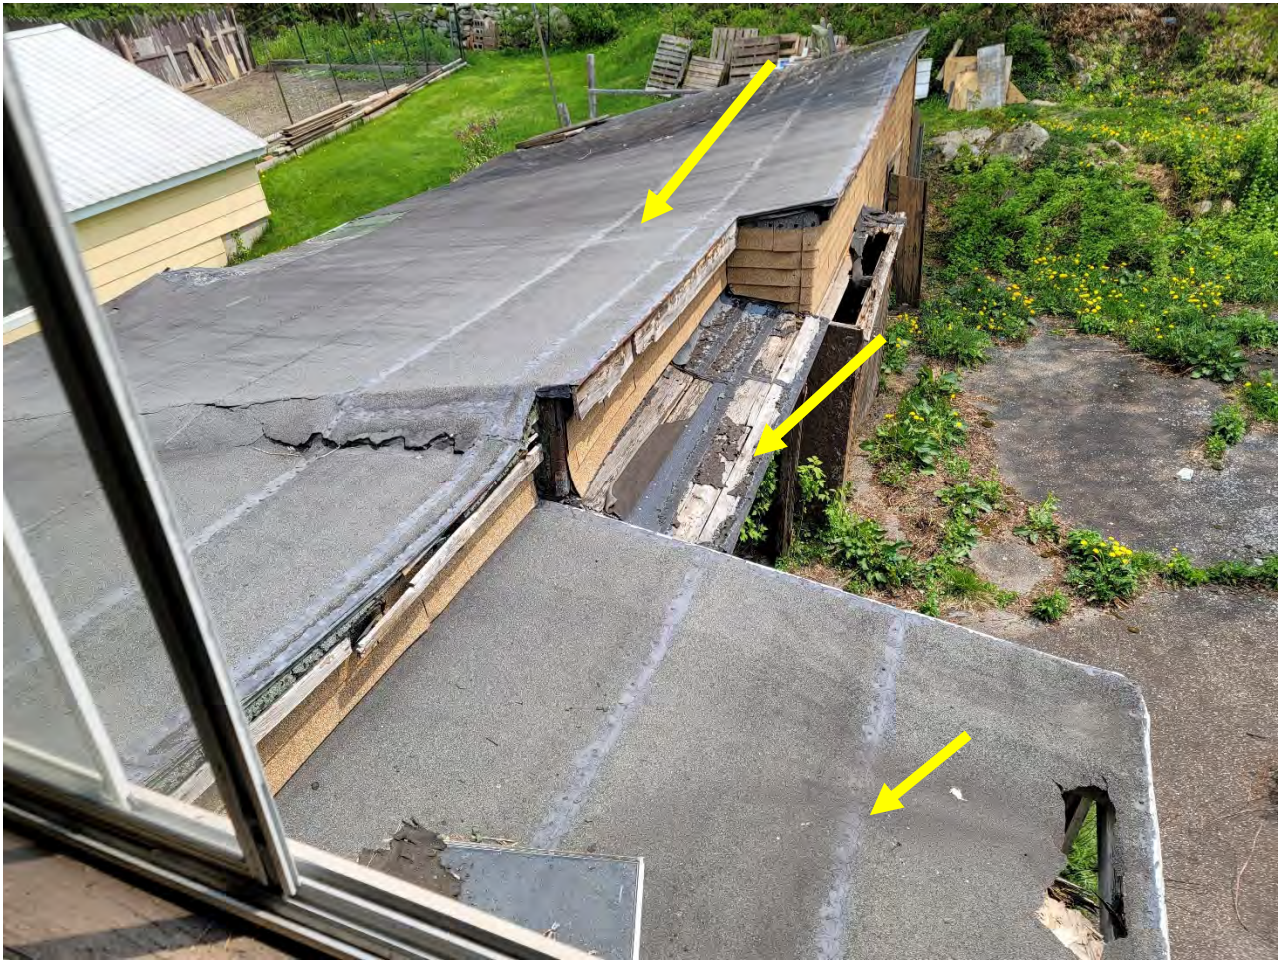
- a. Asphalt roofing mastic/cement (roof area ±1,100 Ft²) applied to the rolled roofing and roof components, including the fabric reinforcement material of the attached shed/garage roof and doorway overhangs, (Line #18, Sample #S-2; Line #25 , Sample S-9; Line #27 ,Sample # S-11; Line #33, Sample S-17) was determined to contain 3% – 7% chrysotile asbestos.
- b. Linoleum cabinet and drawer liners placed in the kitchen cabinets of the 1st floor residence (Line #124, Sample #1-12; Line #125, Sample #1-13) was determined to contain 5% to 8% chrysotile asbestos.
- c. Soundproofing applied to the bottom of the kitchen sink of the 1st floor residence (Line #130, Sample # 1-22) was determined to contain 4% chrysotile asbestos.
- d. Floor tiles (9" x 9", pink tiles and brown tiles) installed in the 1st floor entryway were determined to contain 6% and 3% chrysotile asbestos respectively.

Garage Shed roofs with ACM Mastic/cement.

Pre-demolition notifications to local, State and/or Federal regulatory agencies have not been completed by Calex and are the responsibility of the building owner. Prior to initiation of any demolition activities, all identified ACBM (Asbestos Containing Building Materials) must be properly removed (abated) from the building structure.
