# Pre-Demolition NESHAP Building Inspection

**Site:**  
426 Burgess Street  
Berlin, NH

**Inspection Date:** June 1, 2023  
**Report Date:** July 4, 2023  
**Revised:** October 18, 2023  
**Calex Project:** BER-22-003A/B

**Re: Pre-Demolition Building Inspection  
Residential Multi-Family Building  
426 Burgess Street, Berlin, NH (the Site)**

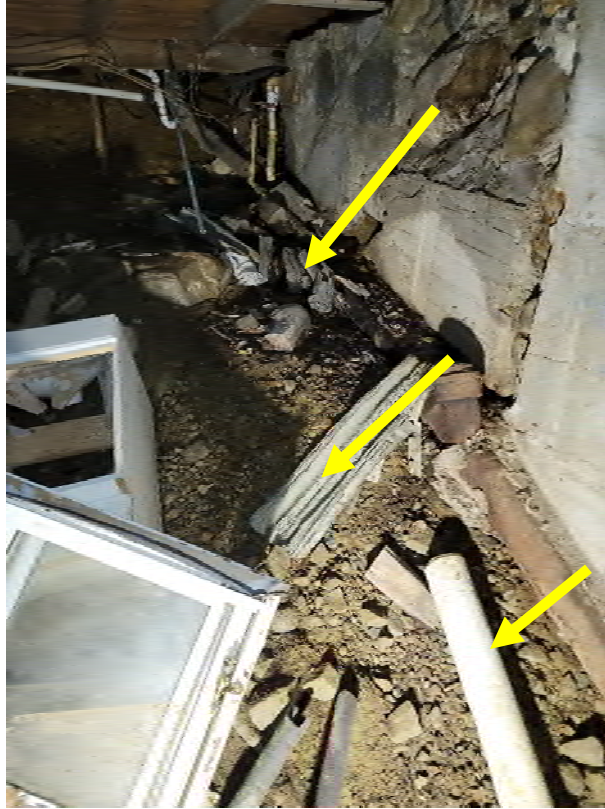
- d. Transite board located in the basement, over the furnace is presumed to contain >1% asbestos.
- e. Aircell pipe insulation located on the basement floor, and the closet of the first floor Bedroom 1 is presumed to contain >1% asbestos.

Air cell (ACM) pipe insulation on basement floor.

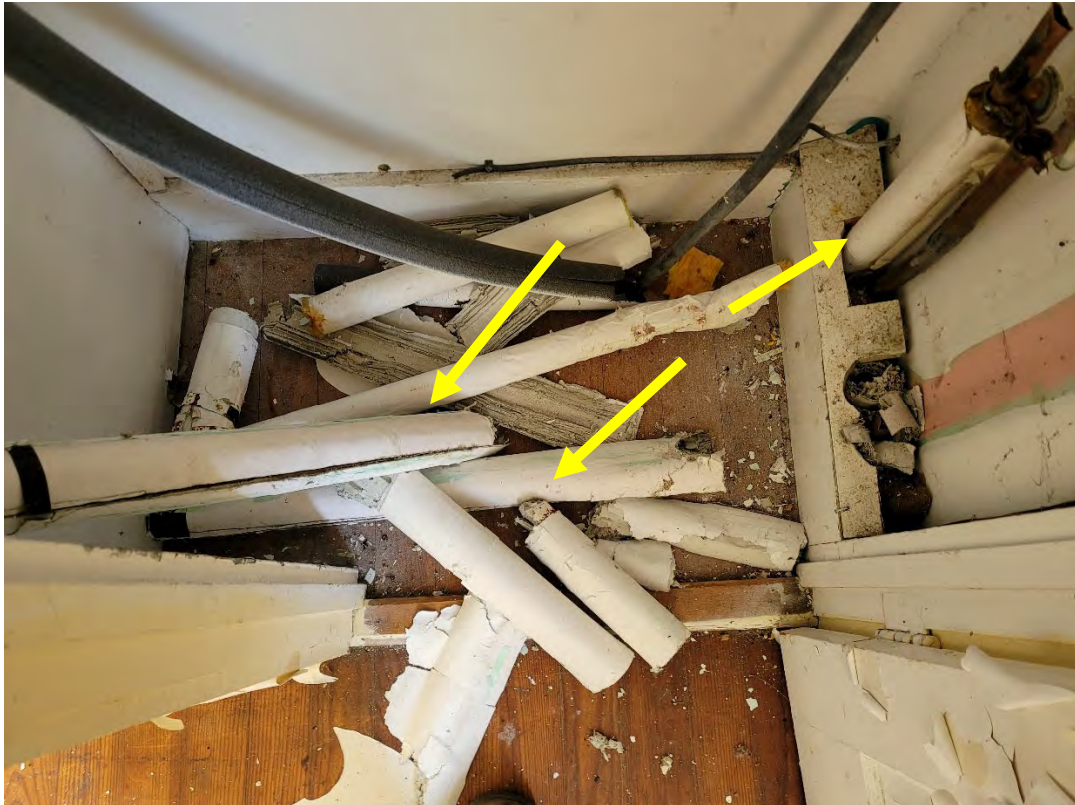
Air cell (ACM) pipe insulation 1<sup>st</sup> floor, bedroom 1, closet.

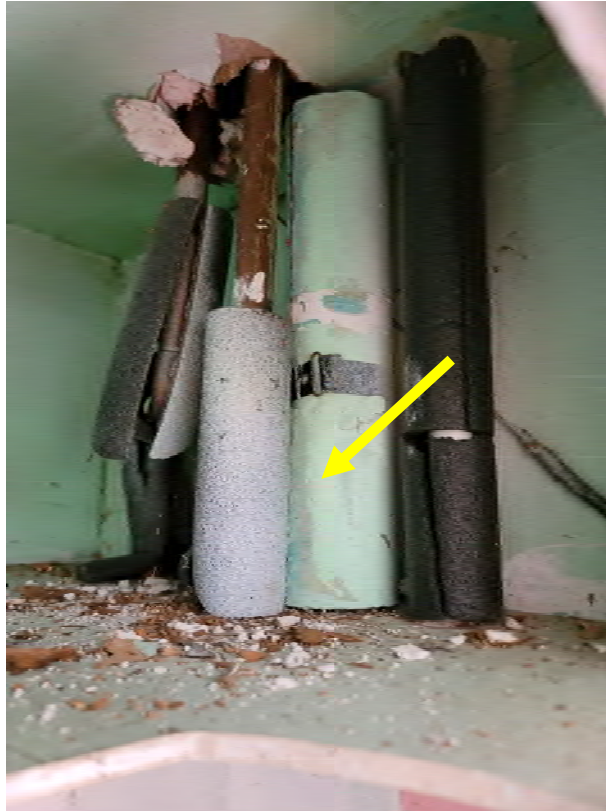
Air cell (ACM) pipe insulation 1<sup>st</sup> floor, bedroom 1, closet above shelf.

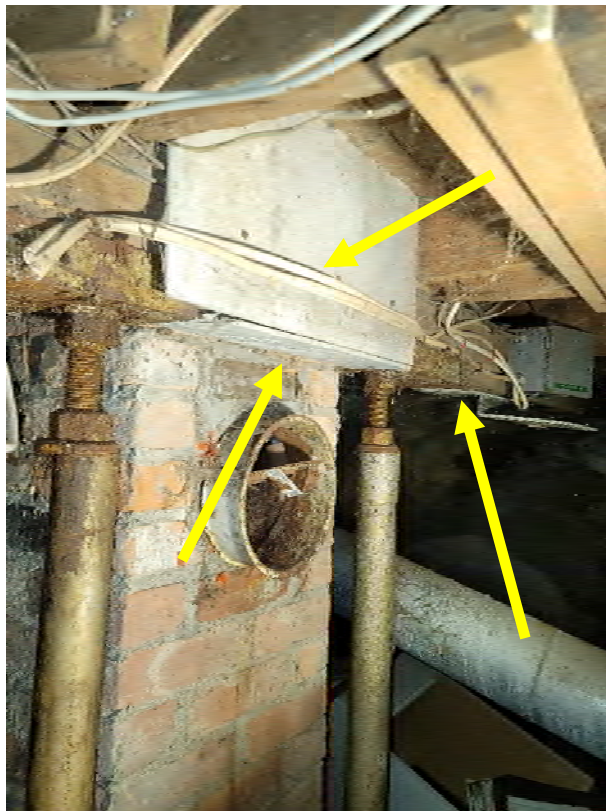
Transite (ACM) board, basement furnace area.

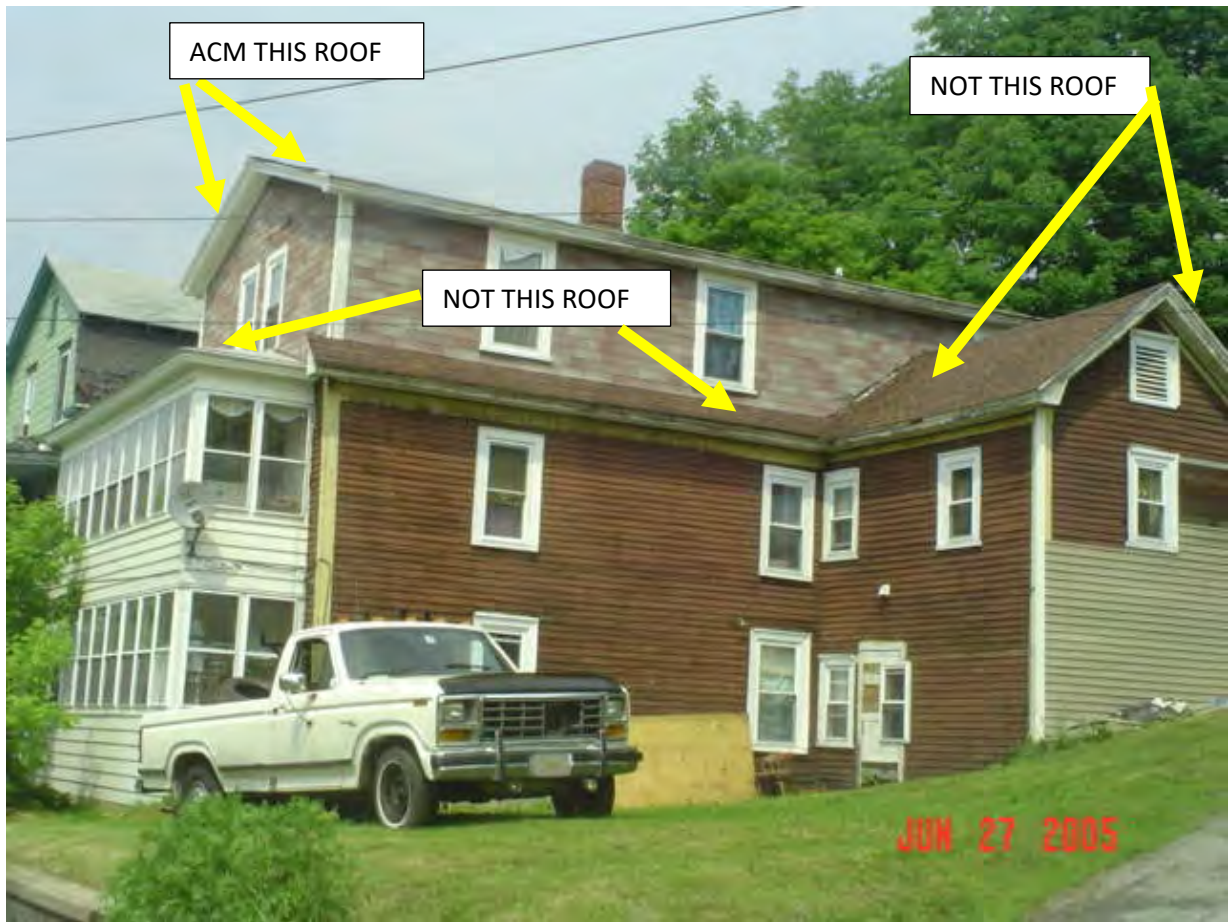
- a. Asphalt roofing on the main roof structure extending over the 3<sup>rd</sup> floor porch (north) roof, (Layer 5, i.e., bottom roof layer), (Line #17, Sample #E-17) was determined to contain 1.40% - 2% chrysotile asbestos. (Note: Does not include roof on 2<sup>nd</sup> floor rear (east) porch roof or 2<sup>nd</sup> floor lower roofs over ell and overhang (south) or 2<sup>nd</sup> floor front (west) porch roof.)

Asphalt Roofing (ACM) main roof and extending over 3<sup>rd</sup> floor porch on north side of building.
