# Pre-Demolition NESHAP Building Inspection

609 Hillsboro Street  
Berlin, NH

**Inspection Date:** June 8, 2023

**Re: Pre-Demolition Building Inspection  
Residential Multi-Family Building  
609 Hillsboro Street, Berlin, NH (the Site)**

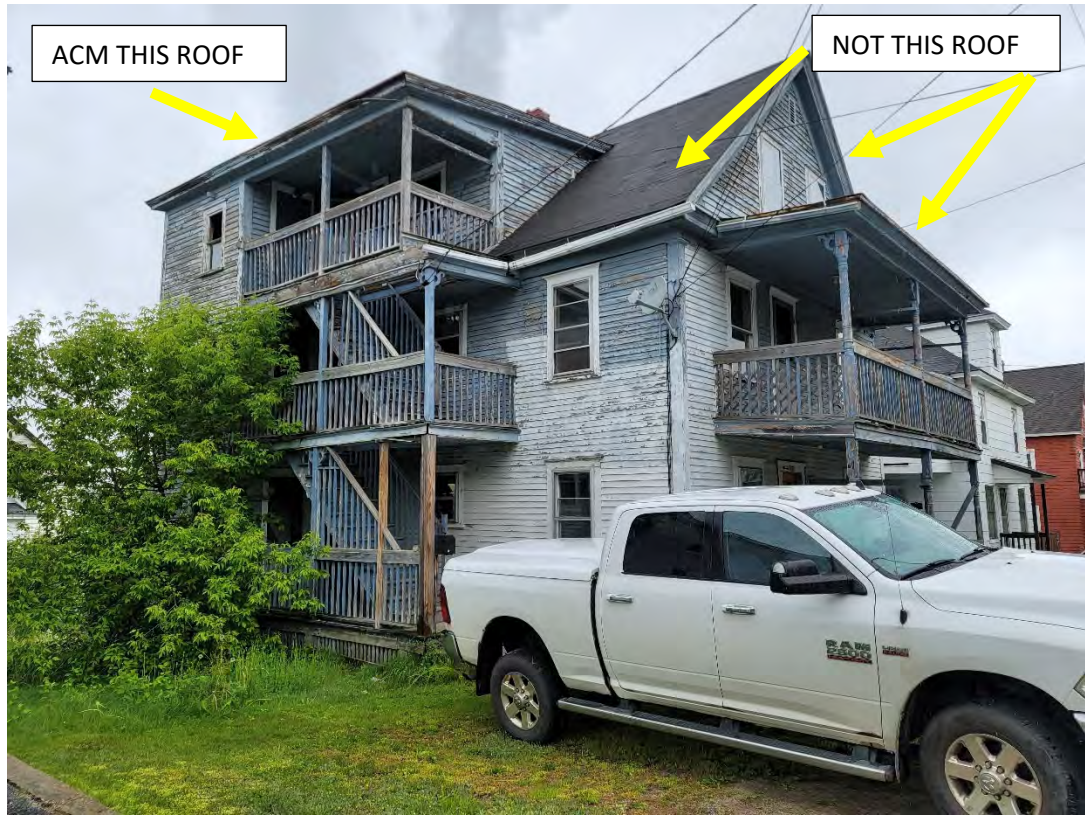
- c. Asphalt roofing on the single pitched flat roof above the south side porches and rear building addition (silver painted roof) was determined to contain 1.3 – 2.9% chrysotile asbestos, (Line #32, Sample #E-28; Line #33, Sample #E-29; Line #34, Sample #E-30; Line #35, Sample #E-31). Both the top layer of silver paint/mastic and the bottom layer (Layer 2) of roofing material are classified as ACM.

ACM roofing on south porch and "bump out" roof.

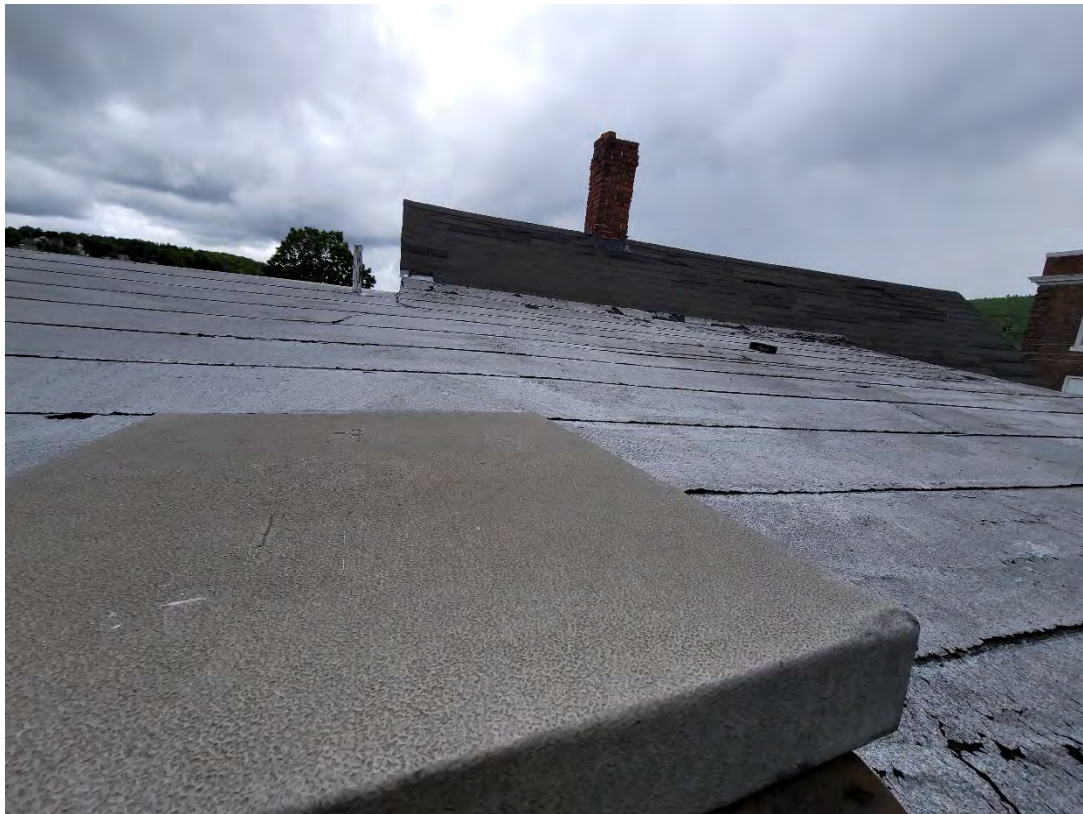
ACM roofing on south porch and "bump out" roof. Roof hatch in foreground.

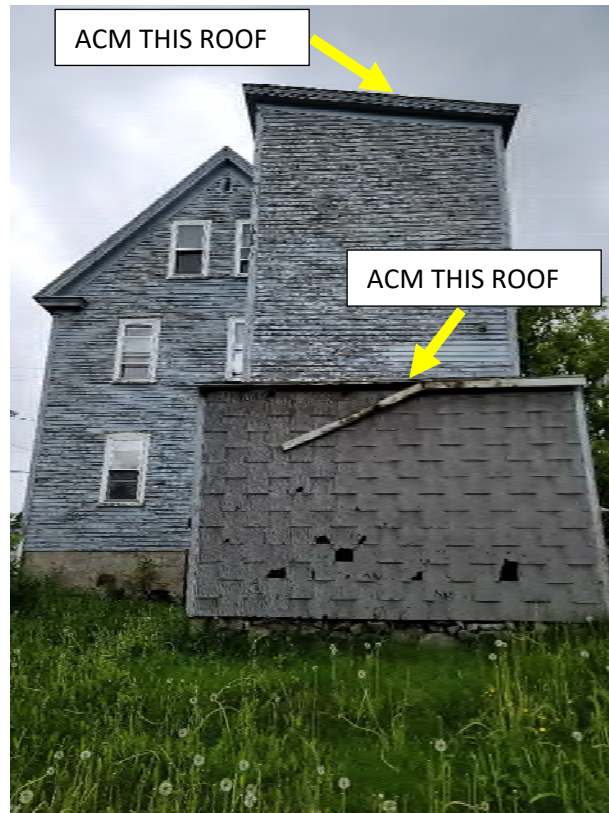
- a. Transite board located in the basement above the furnace (located above a layer of cement board) is presumed to contain >1% asbestos.
- b. Asphalt roofing on the attached shed situated at the western end of the buildings (Line #22, Sample #E-18) was determined to contain 2% to 3.1% chrysotile asbestos. Note: Some portions of asphalt roofing are heavily weathered and have become friable.

ACM roofing on south porch and "bump out" roof (top) and rear shed (bottom).

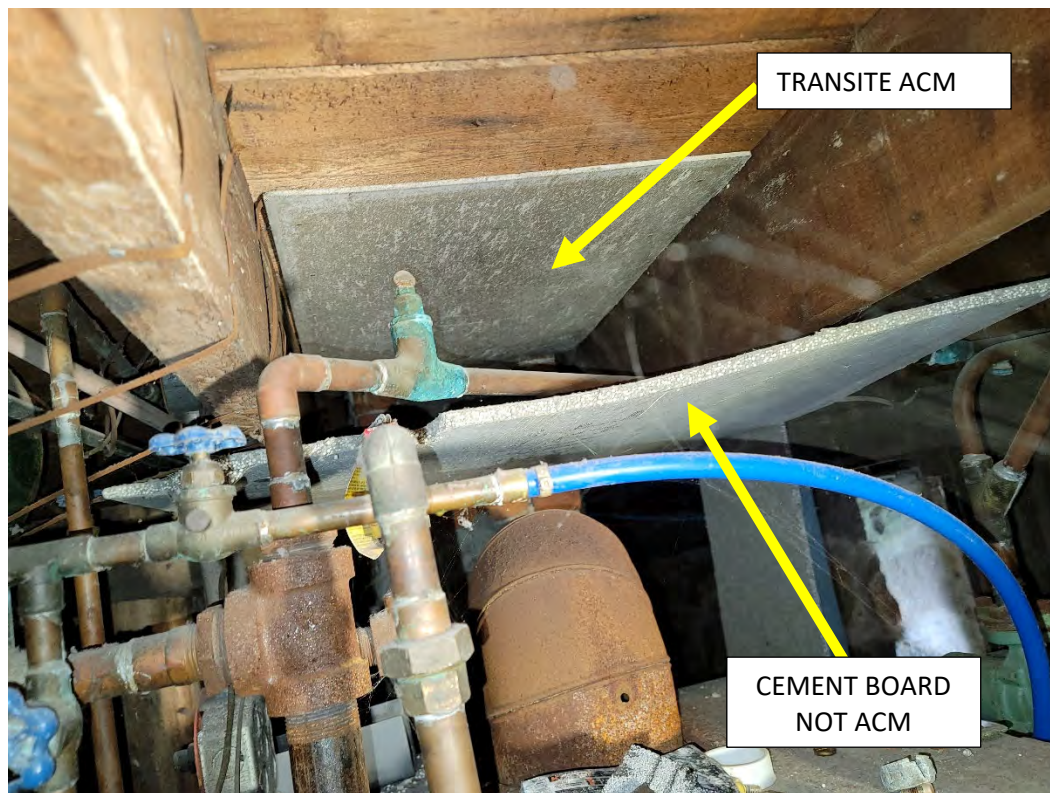
Transite (ACM) board, basement furnace area.
