Pre-Demolition NESHAP Building Inspection

Site:
827 Western Avenue
Berlin, NH

Inspection Date: June 17, 2023
Report Date: July 8, 2023
Calex Project: BER-22-005A/B

**Re: Pre-Demolition Building Inspection
Residential Multi-Family Building and Two Residential Garages
827 Western Avenue, Berlin, NH (the Site)**

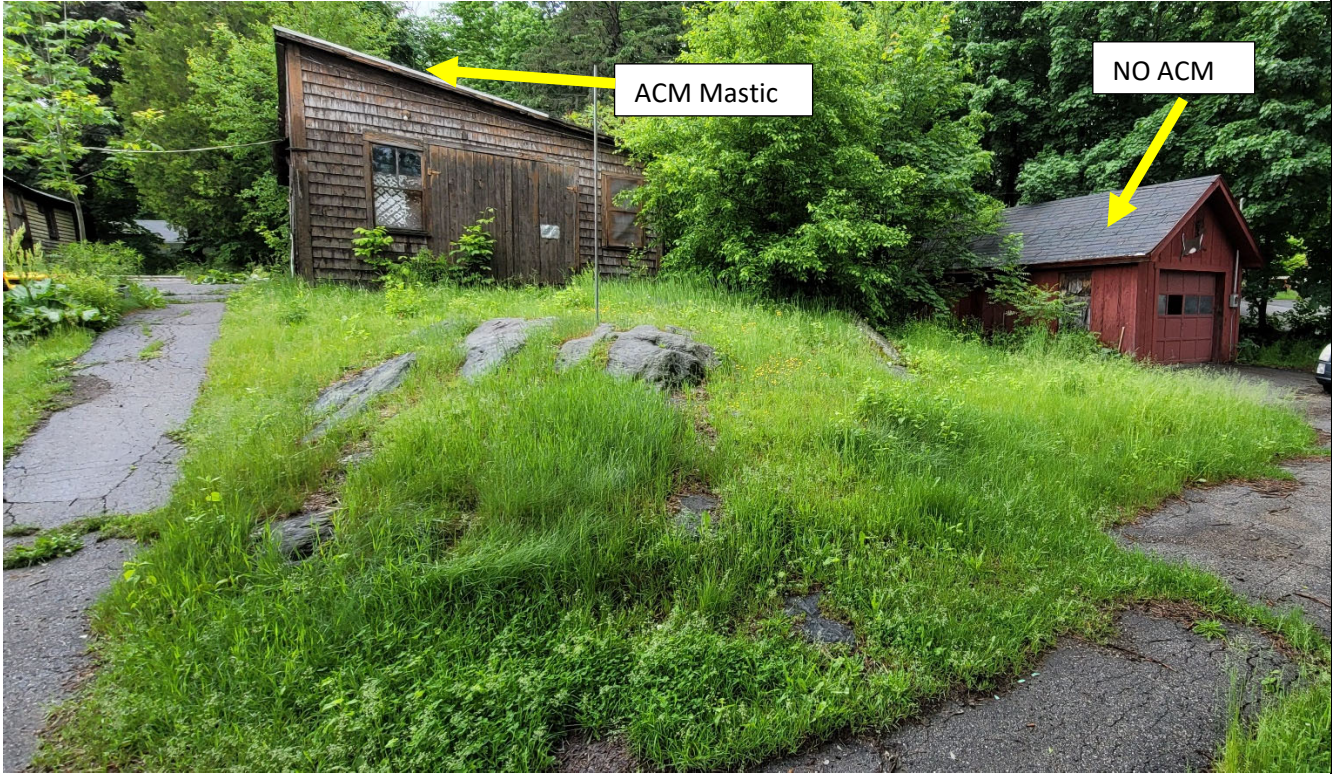
Garage 1 (Western Ave access) Left; Garage 2 (Gerrish St. access), Right

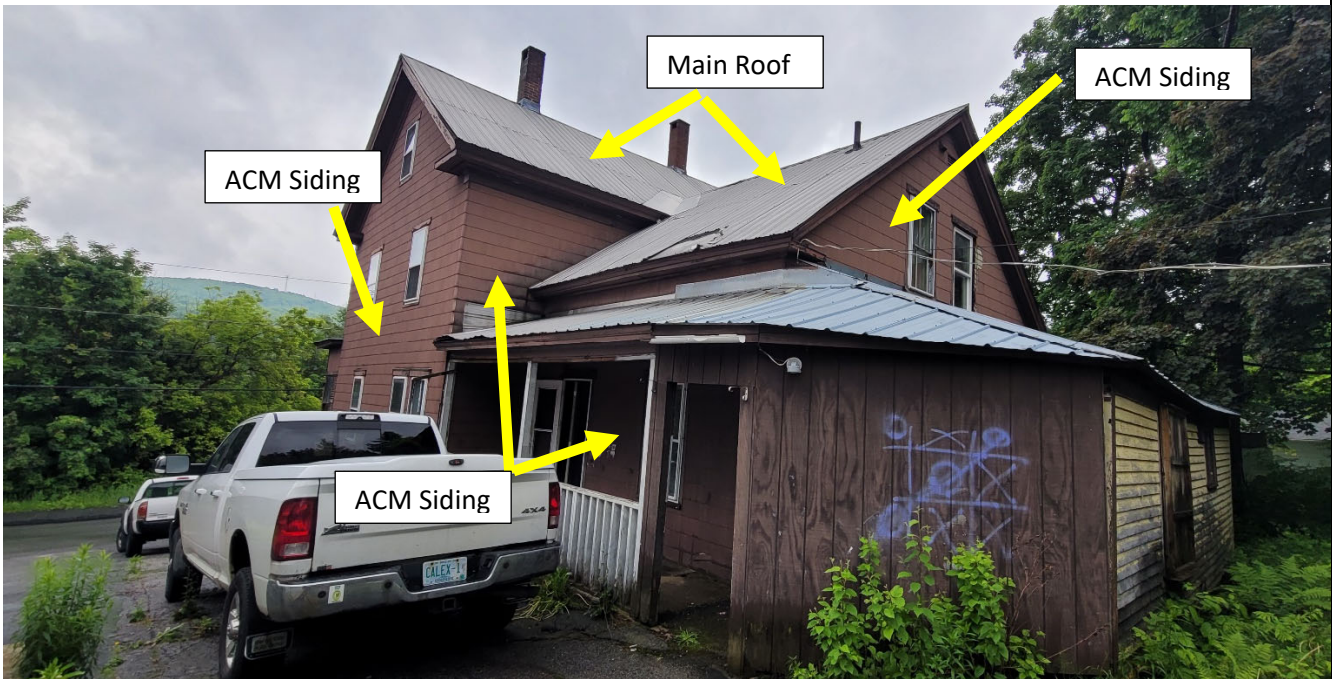
Cementitious (Transite) siding and roof designations.

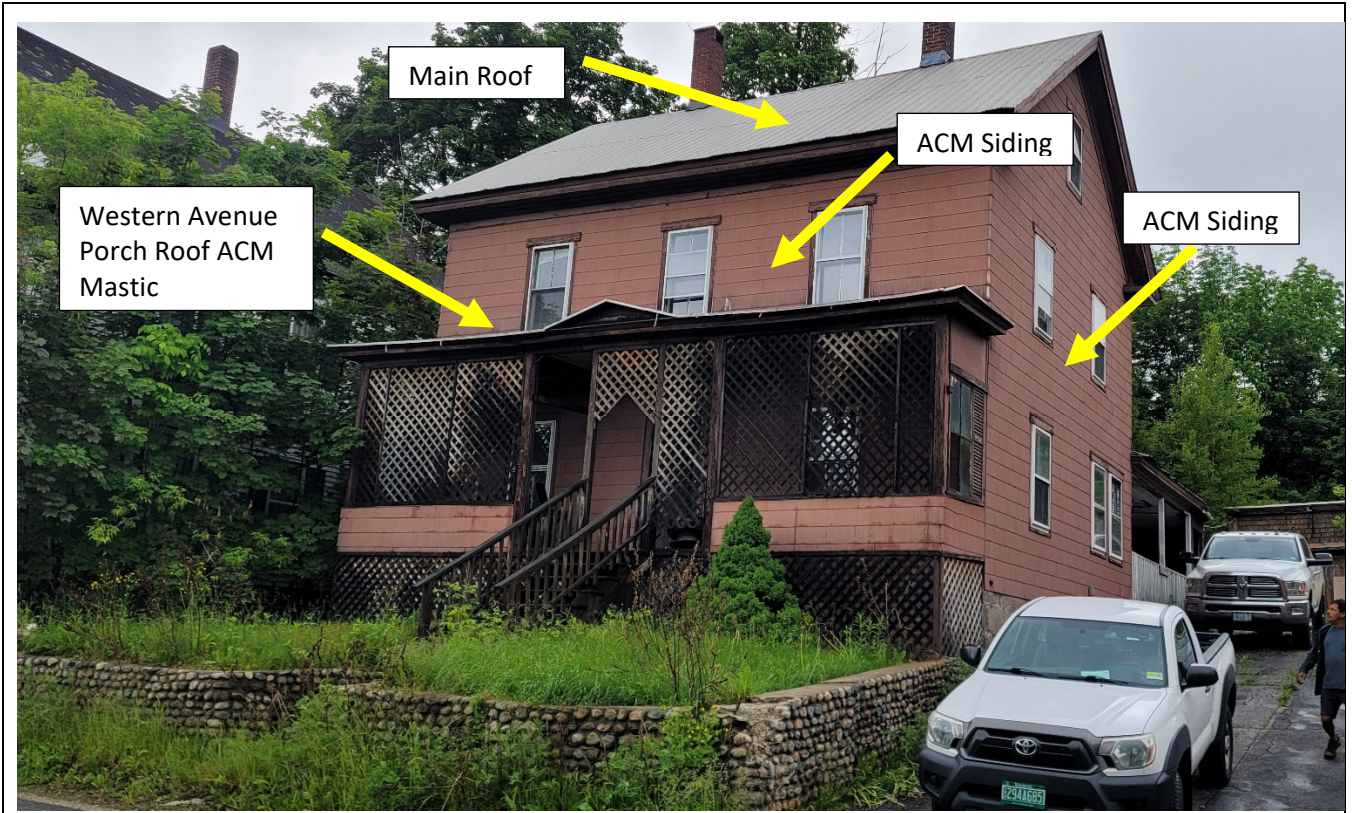
Roof designations and Cementitious (Transite) ACM siding.

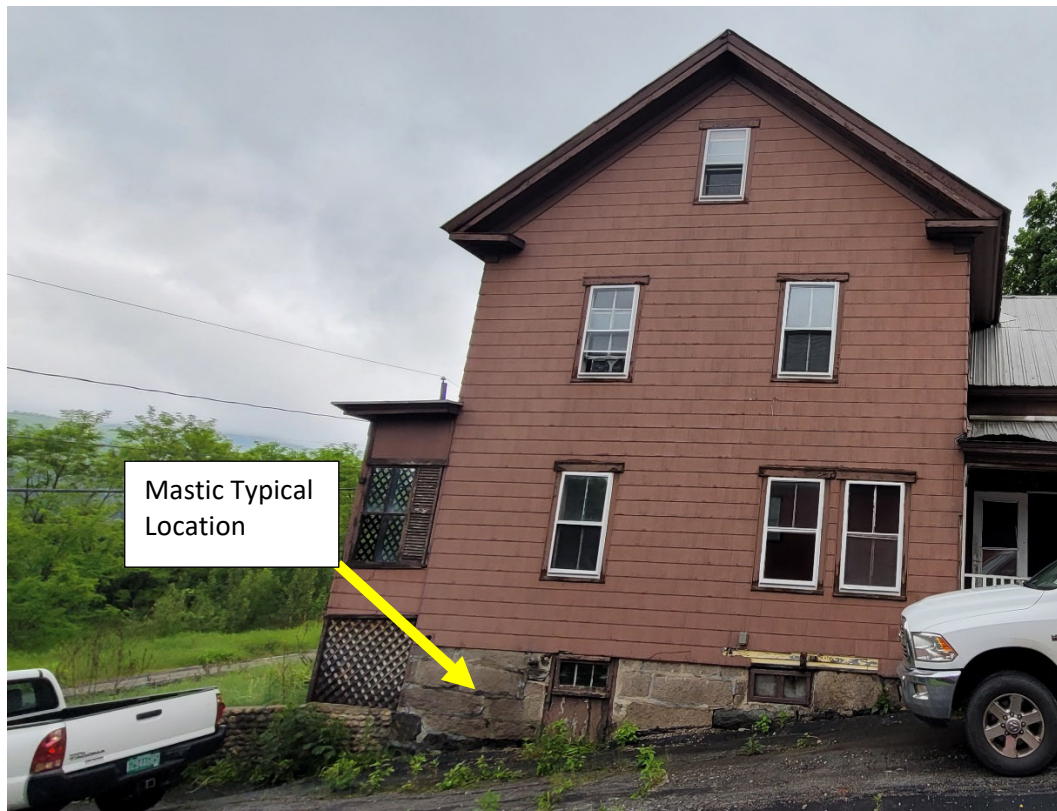
Asphaltic Foundation Mastic (typical).
