Pre-Demolition NESHAP Building Inspection

37-39 Cambridge Street
Berlin, NH

Inspection Date: June 27, 2023

**Re: Pre-Demolition Building Inspection
Residential Multi-Family Building and Residential Garage
37-39 Cambridge Street, Berlin, NH (the Site)**

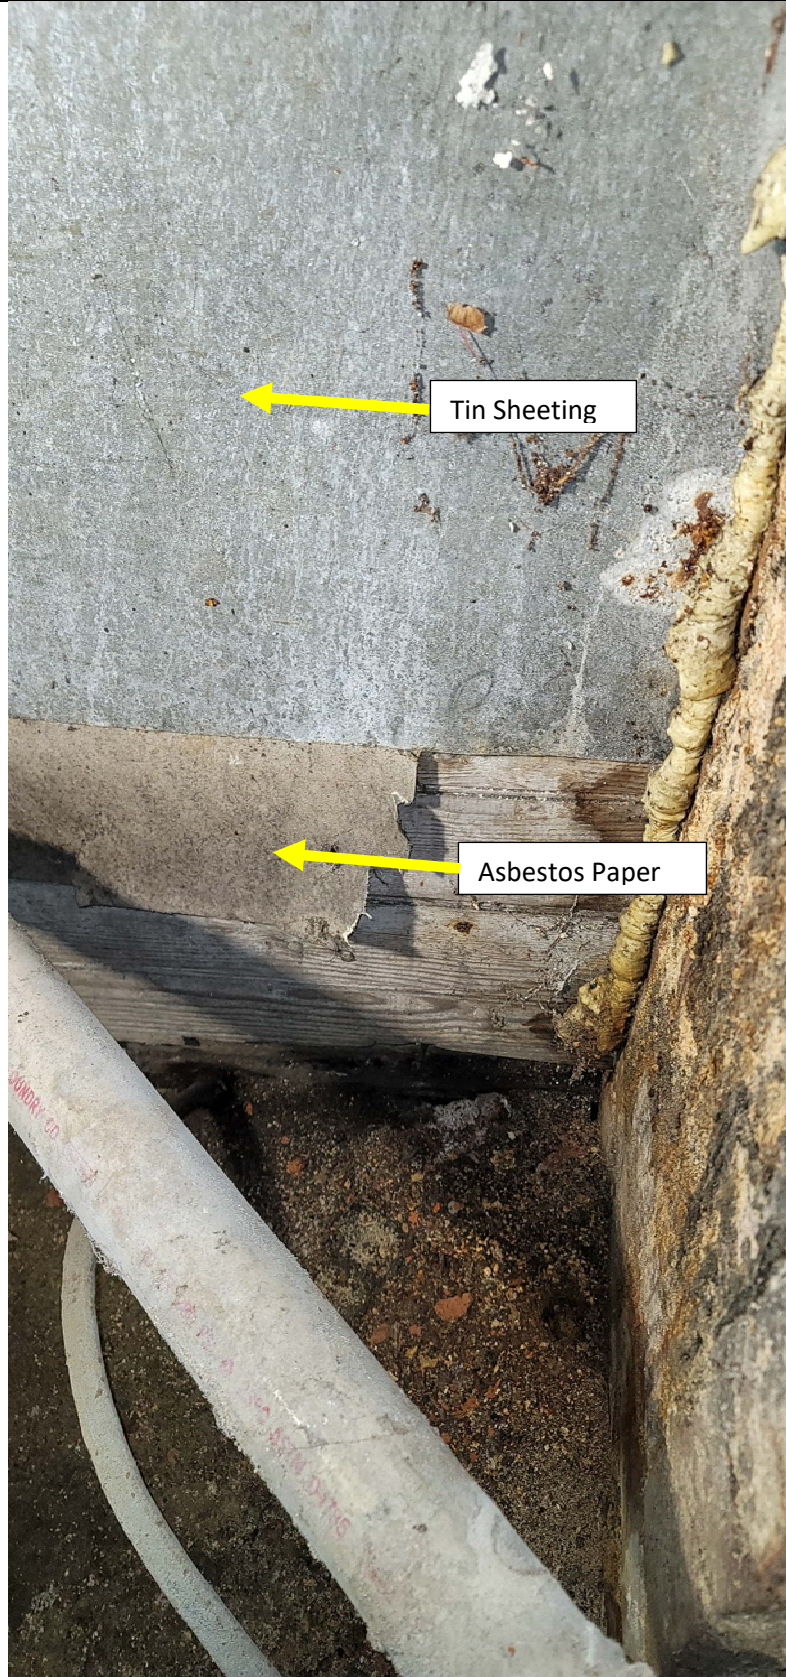
- c. Asbestos paper applied to a support column and wall (covered with tin sheeting) located nearby the basement furnace (Line #62, Sample #B-1; Line #63, Sample #B-2) was determined to contain 45% chrysotile asbestos.

Asbestos Paper (Sample B2) in Basement, Behind Tin Sheetting.

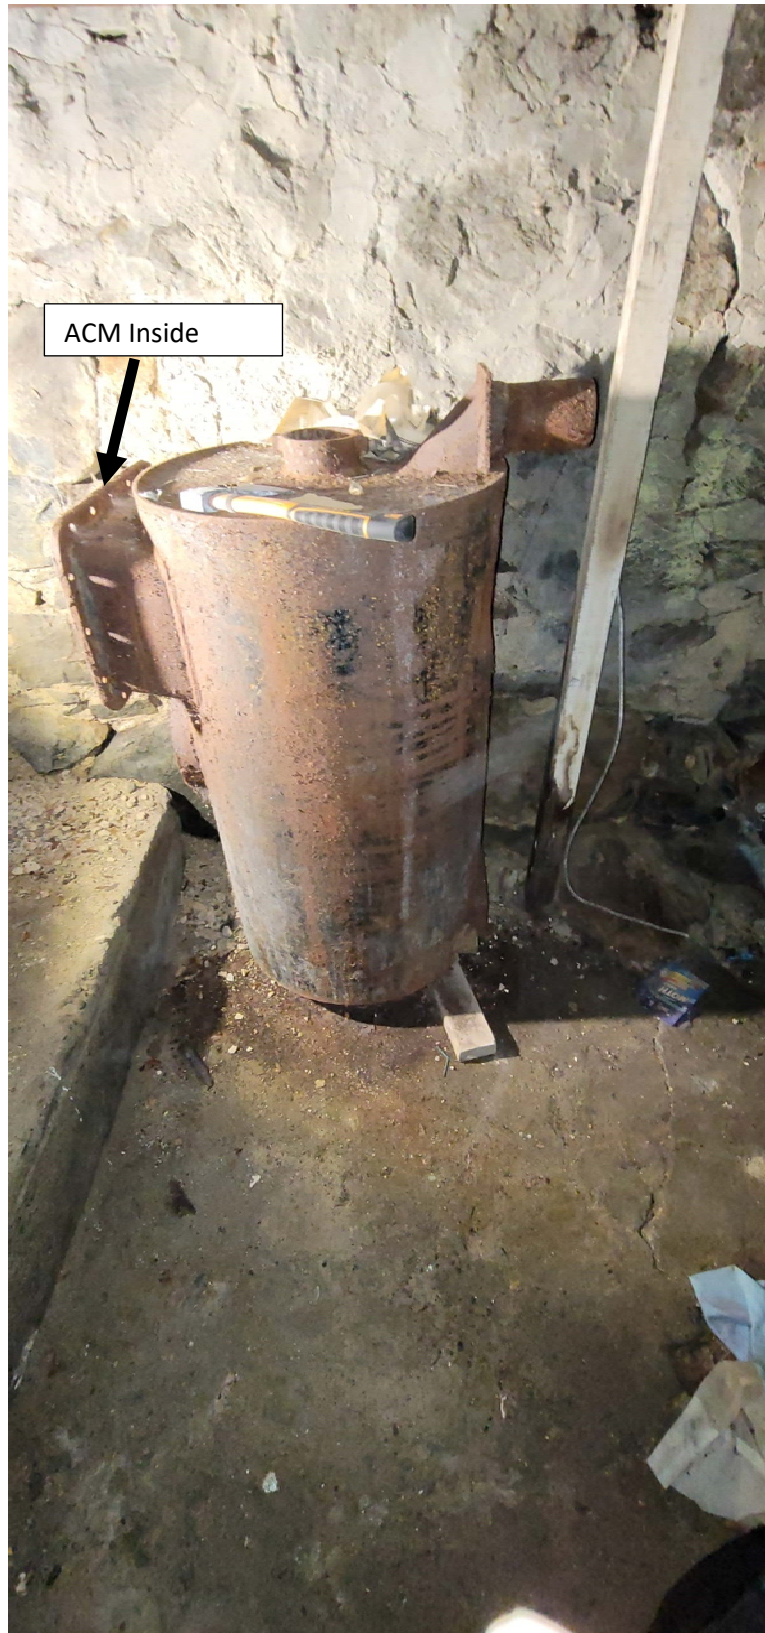
- d. Aircell pipe insulation remnants inside of an abandoned boiler located in the basement, (Line #64, Sample #B-3; was determined to contain 50% chrysotile asbestos.

Abandoned Boiler in Basement. Aircell (ACM) Pipe Insulation Remnants Inside (Sample B-3).

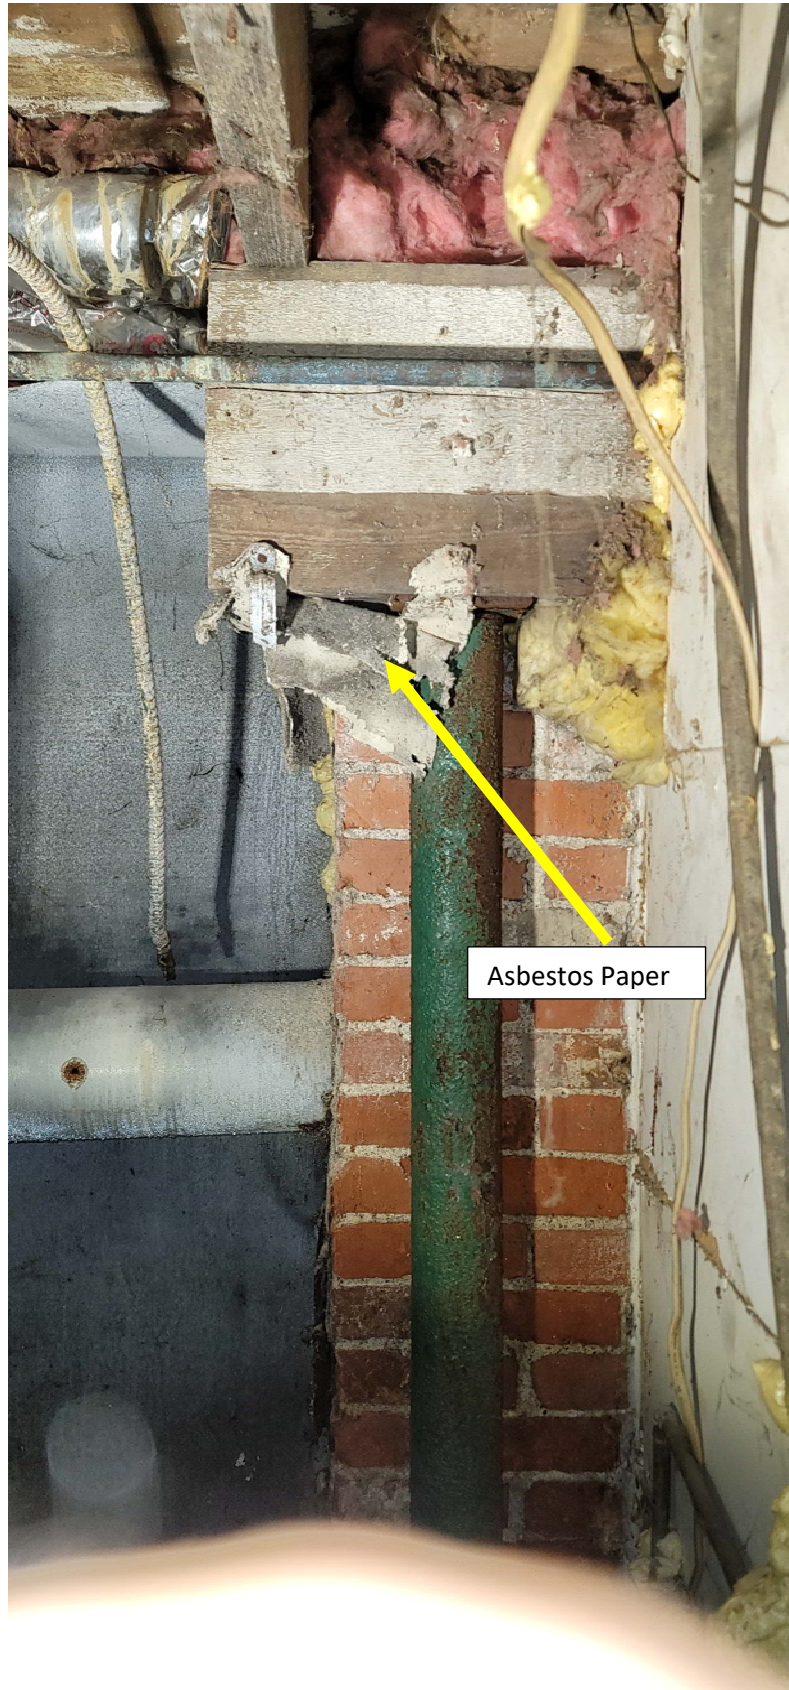
Asbestos Paper Near Column in Basement (Sample B-1)
