Pre-Demolition NESHAP Building Inspection

96-98 Hillside Avenue
Berlin, NH

Inspection Date: June 29, 2023

Calex Project: BER-22-007A/B

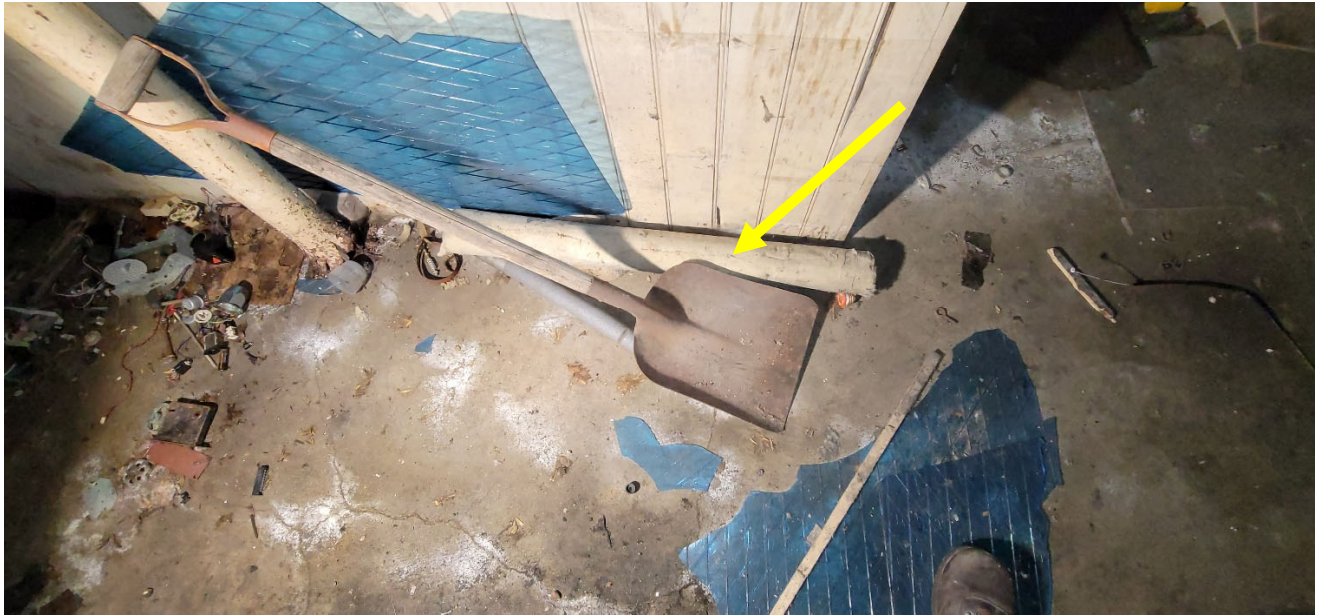
- g. Aircell piping insulation located on piping and additionally as scattered remnants

on the floor of the building basement are presumed to contain >1% asbestos.

Aircell (ACM) pipe insulation on basement floor (typical)

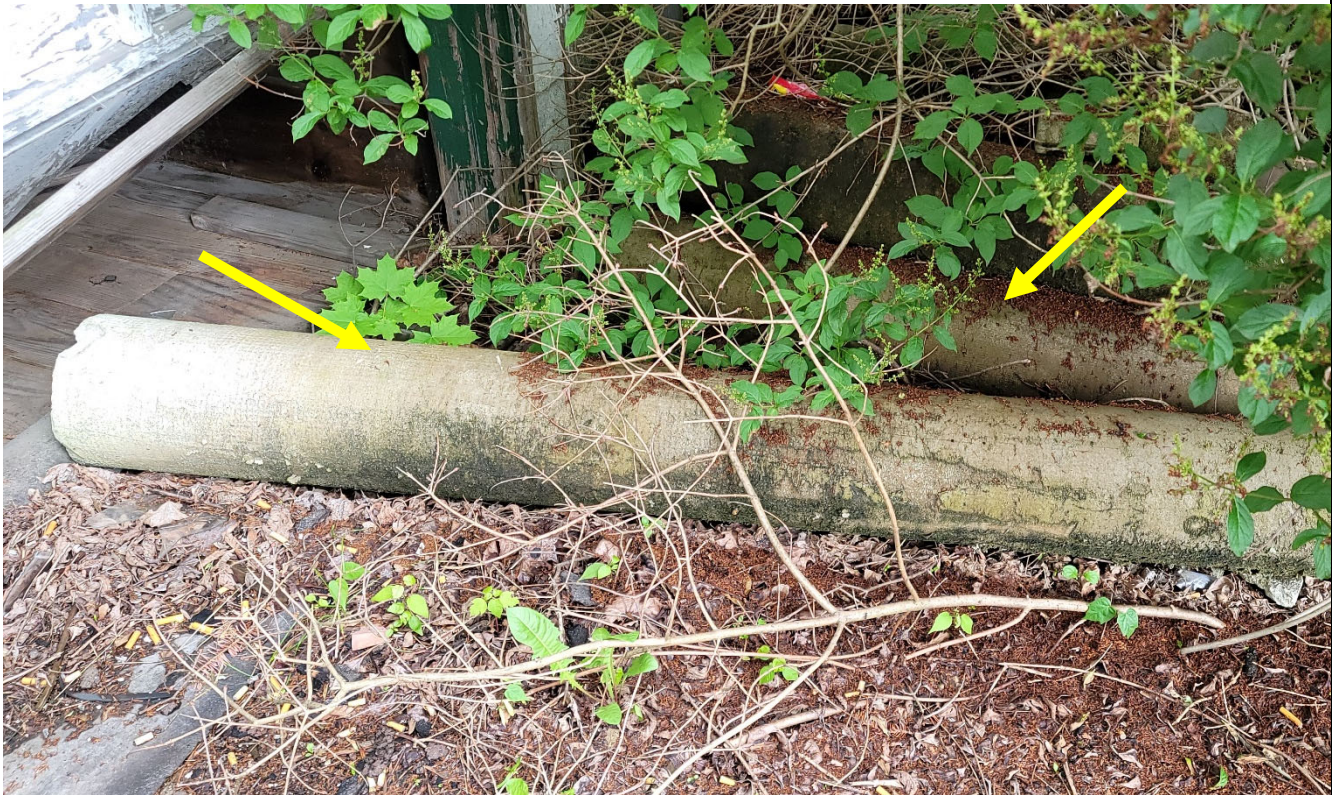
- e. Cementitious (Transite) pipe stored outdoors adjacent to the garage door entrance (Line #61, Sample #G-1) was determined to contain 35% chrysotile asbestos.

Transite pipe stored outside garage.
